# **TOTAL HOME INSPECTION**

99 Hope St. Anywhere NY.  
14005

***Inspection & Report***  
*Completed by*  
*Al Young Chief Inspector*  
**TOTAL HOME INSPECTION**

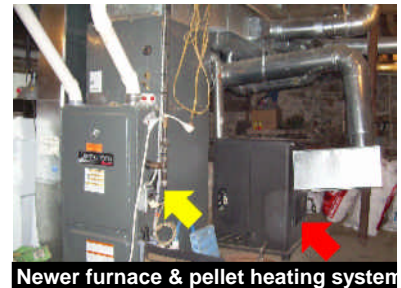
Two types of heating systems installed both appear to be serviceable.

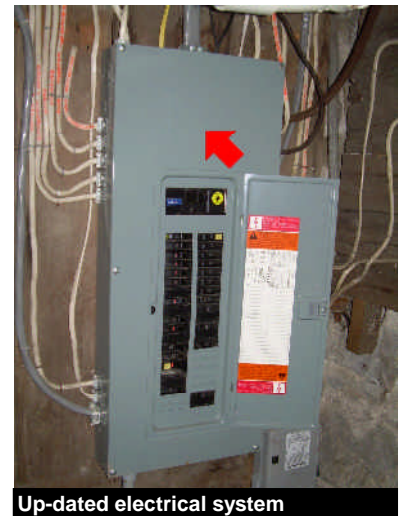
Good overall conditions appears serviceable. 200 amp.

Up-dated electrical system

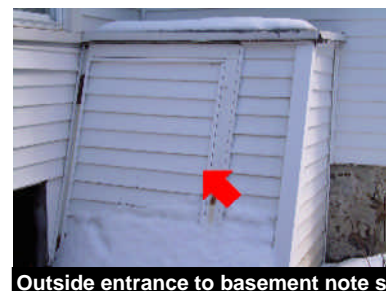
Outside entrance to basement note sr

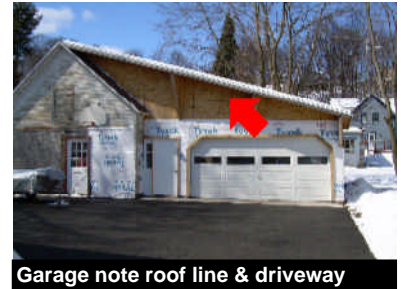
Large 3-stall garage located in rear of property it is noted that this is not completed needs siding & trim work, but building is weather tight and is functional.

Garage note roof line & driveway

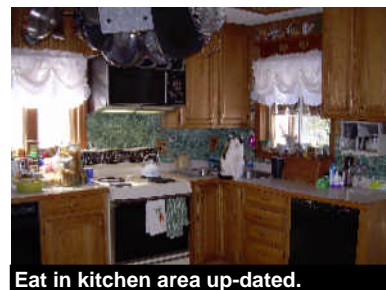
Many improvements noted and newer kitchen installed.

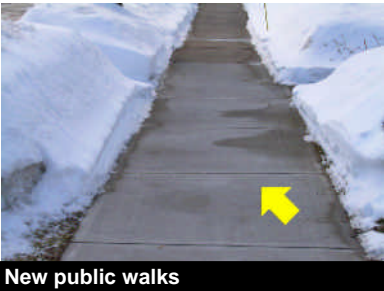
Newer side walks installed.
